Contact: Kimberly Dinwiddie
503-539-8454
Kimberly.Dinwiddie@odot.state.or.us
Jan. 26, 2018

Oregon 213 Slide Repairs in Mulino

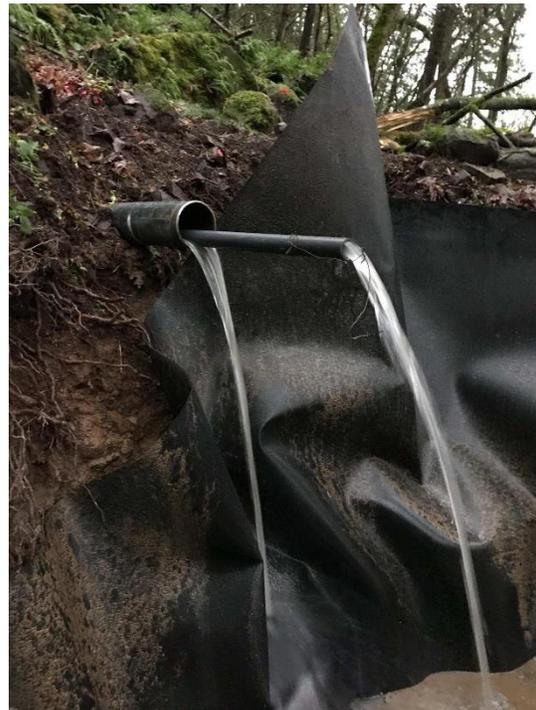
Drains inserted in the slope reduce additional slide movement.

We developed a two-stage plan to address the landslide and the resulting pavement damage. Currently, contractors are installing 40 horizontal drains approximately 40 feet below the highway to help drain water from the landslide area.

In a landslide, water acts as a driving force. The drains will create an easier path for water to drain from the area, reducing the potential for additional movement.

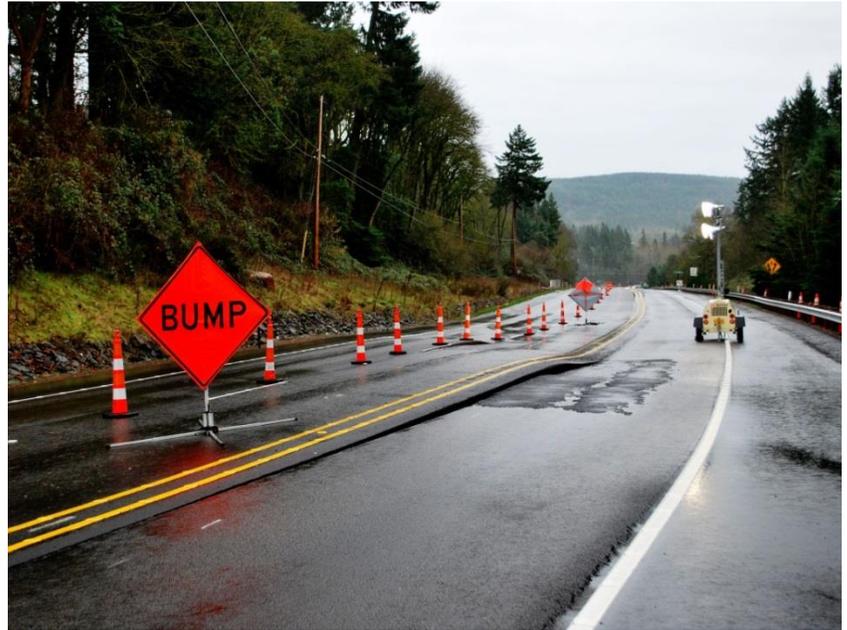
Record setting rains reactivated an ancient landslide in March 2017. The landslide movement caused the southbound lane to drop below the northbound lanes and cracks to form across Oregon 213 (Cascade Highway South) in Mulino near South Eldorado Road.

Cracks and southbound lane sinking below northbound lanes along OR 213 near Mulino.

The first of multiple pavement repairs was completed in October 2017. This included repairing the pavement and was intended to strengthen the road and temporarily repair the abrupt edges running across the highway.

Crews inserted layers of rocks and geogrid, a material used to reinforce the highway base, while paving. The geogrid is a strong plastic material that strengthens the road and allows some movement.
