## Reconnaissance Report

Lolo Pass Road Access Alternatives Project  
OR CLACK 37005 (1)  
Clackamas County, Oregon

October 2014 Reconnaissance Report

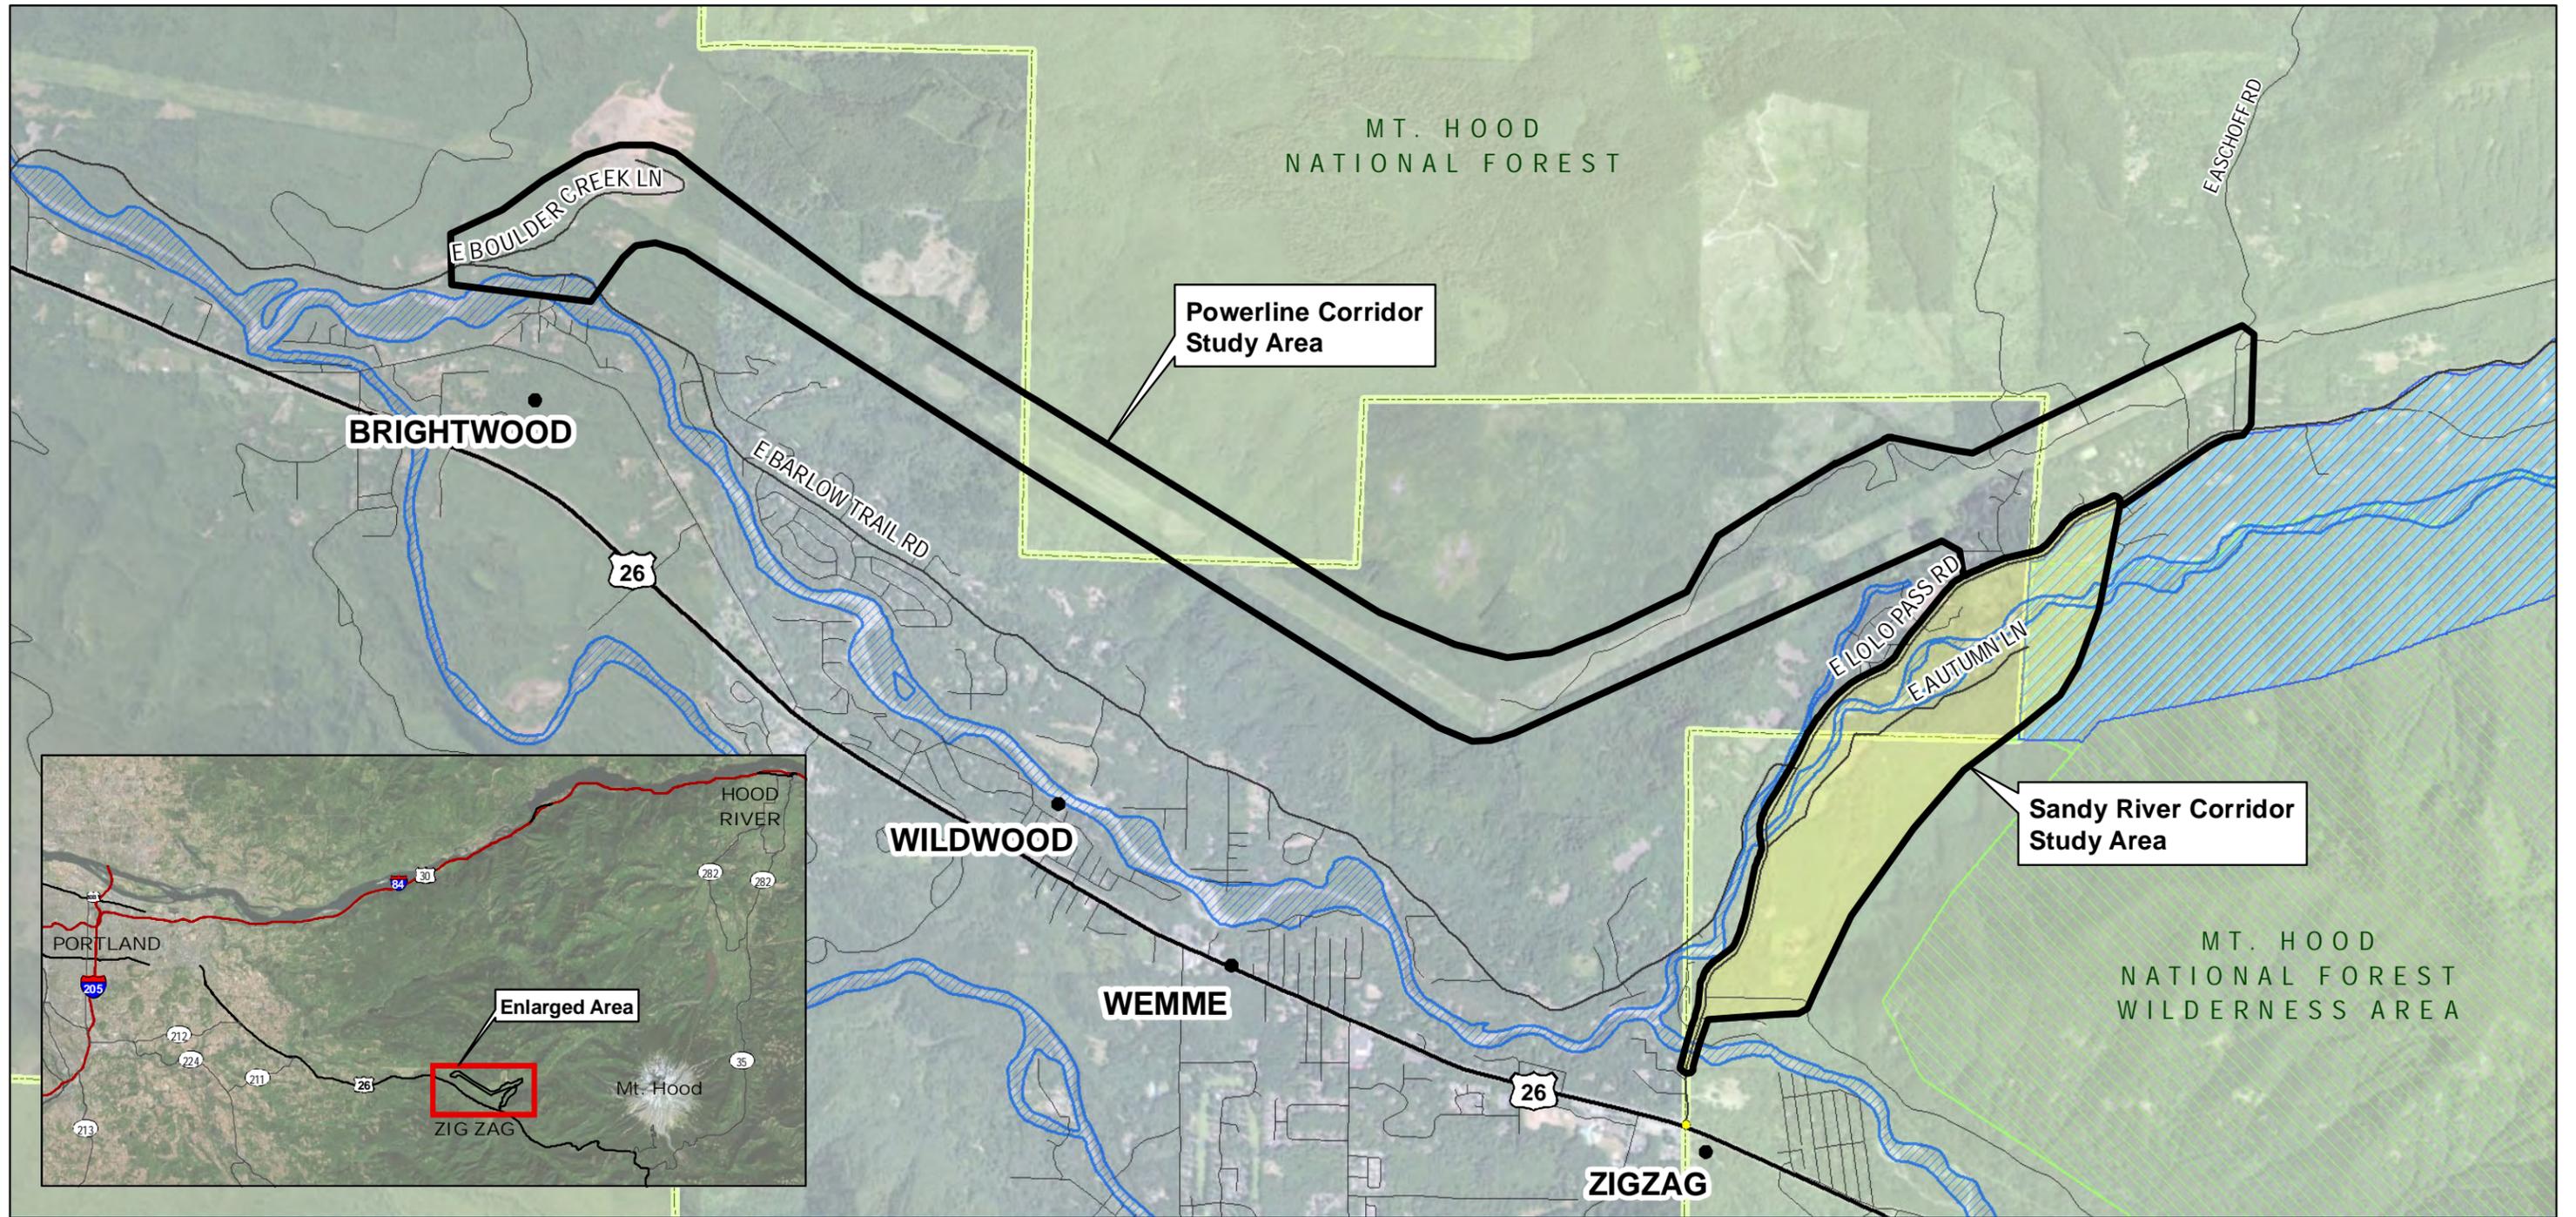
**Figure 1. Areas of Study**

As shown in Figure 1, the project area is located just north of the intersection of U.S. Highway 26 (US 26) and Lolo Pass Road near Mt. Hood Village and Rhododendron, in Clackamas County, Oregon.

Portions of Lolo Pass Road, the road subgrade, and adjoining residential properties were critically damaged during a major Sandy River flood and channel migration in January 2011. The road is in jeopardy of being destroyed by repeated flooding and Sandy River channel migration, which would completely cut off access to public lands used for resources and recreation and rural residential communities. The only currently identified access to the properties and public lands north of the washout requires driving more than 50 miles to Hood River over a mountain pass that is not traversable in the winter due to high snow levels. Figure 1 shows the project area.

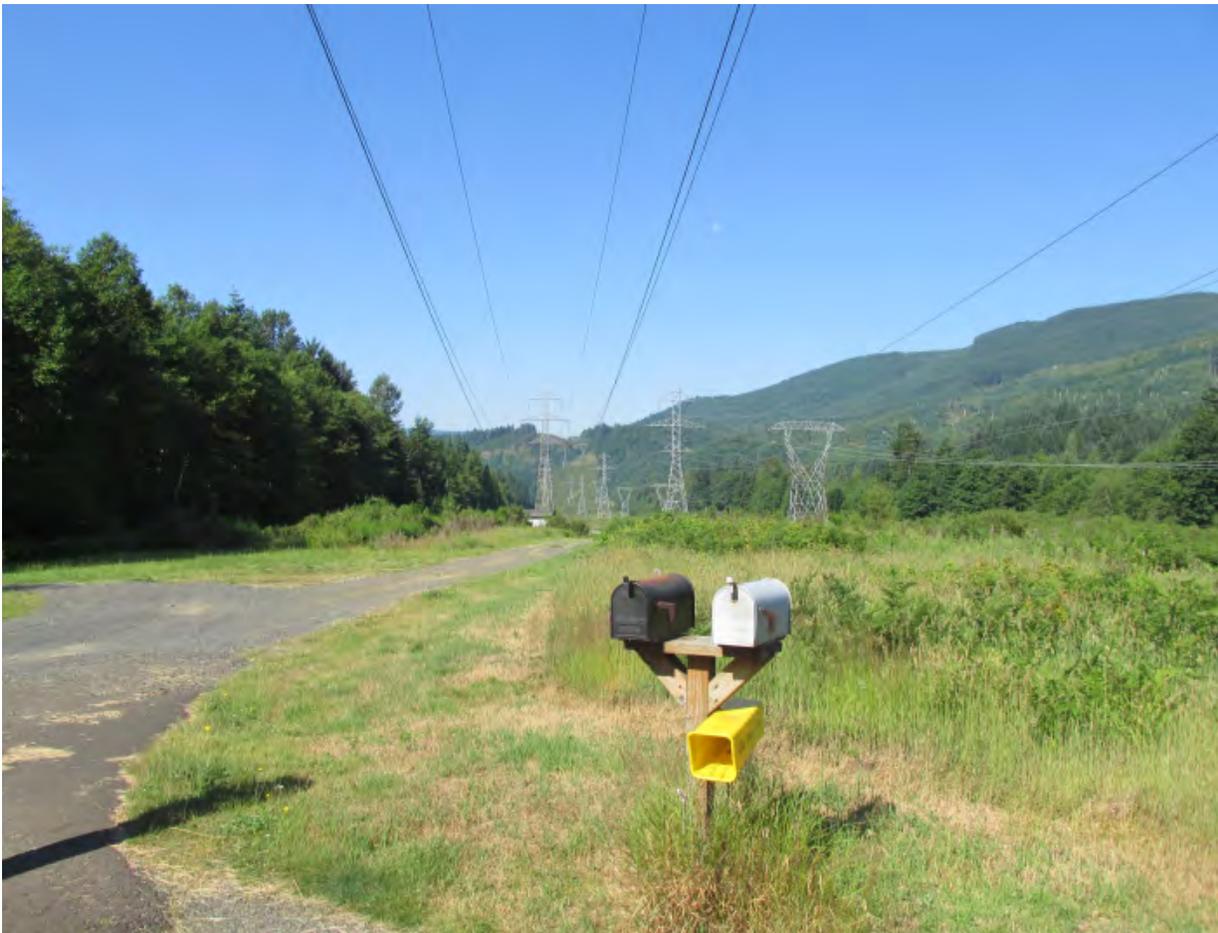
***Powerline Corridor view to west from Ashcroff Road.***

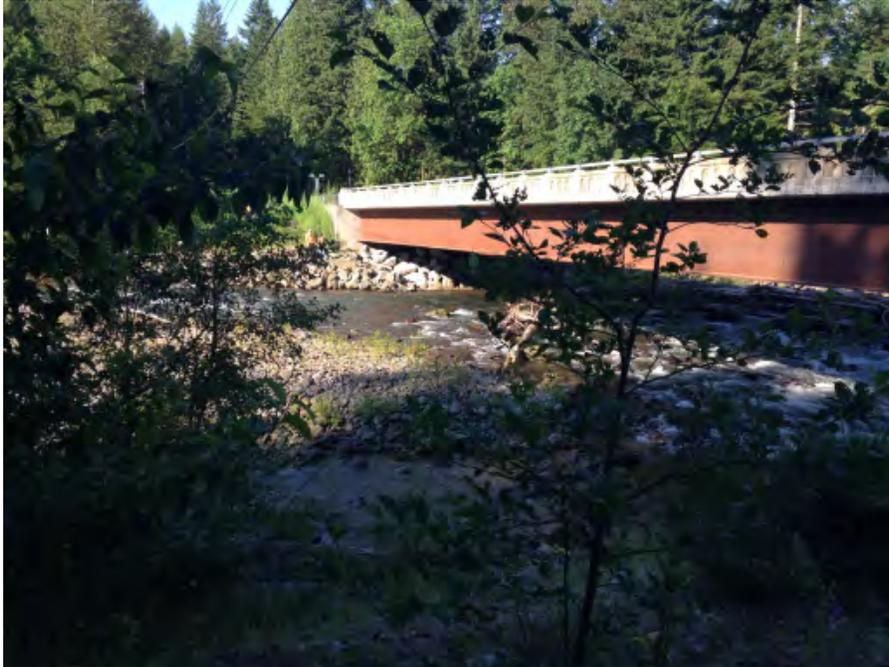
Lolo Pass Road; New Bridge over the Zigzag River

No signs of recent erosion or damage to the emergency repairs made at the Zigzag River (Lolo Pass Road) Bridge were observed during the field reconnaissance. Additional improvements to protect the bridge may not be necessary. However, further hydraulic analysis of the bridge should be performed to ensure that the emergency repairs provide sufficient erosion and scour protection during future floods, and that adequate clearance below the bridge is provided to accommodate anticipated debris flows and channel aggradation or degradation.

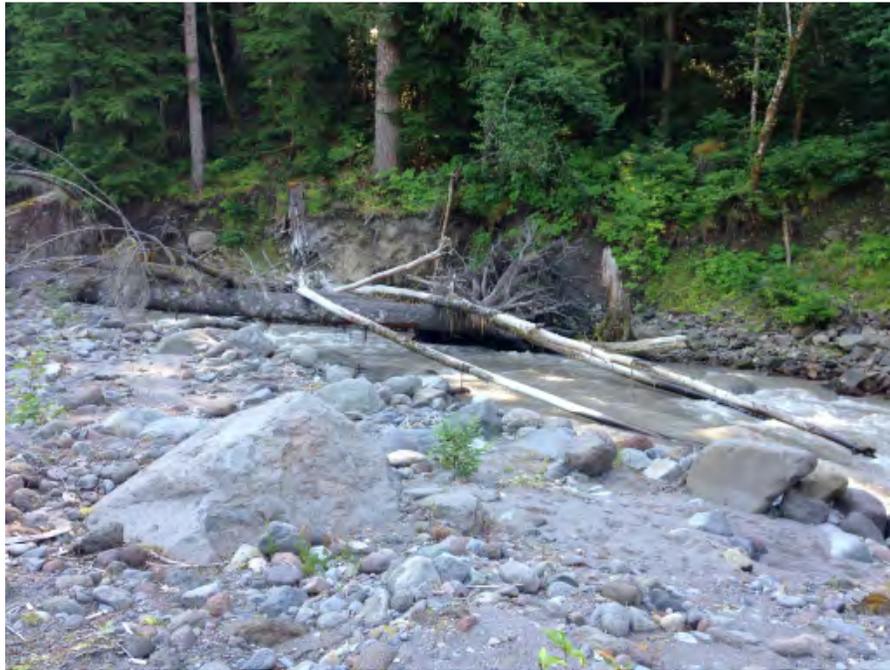
Sandy River, downed trees and flood deposits

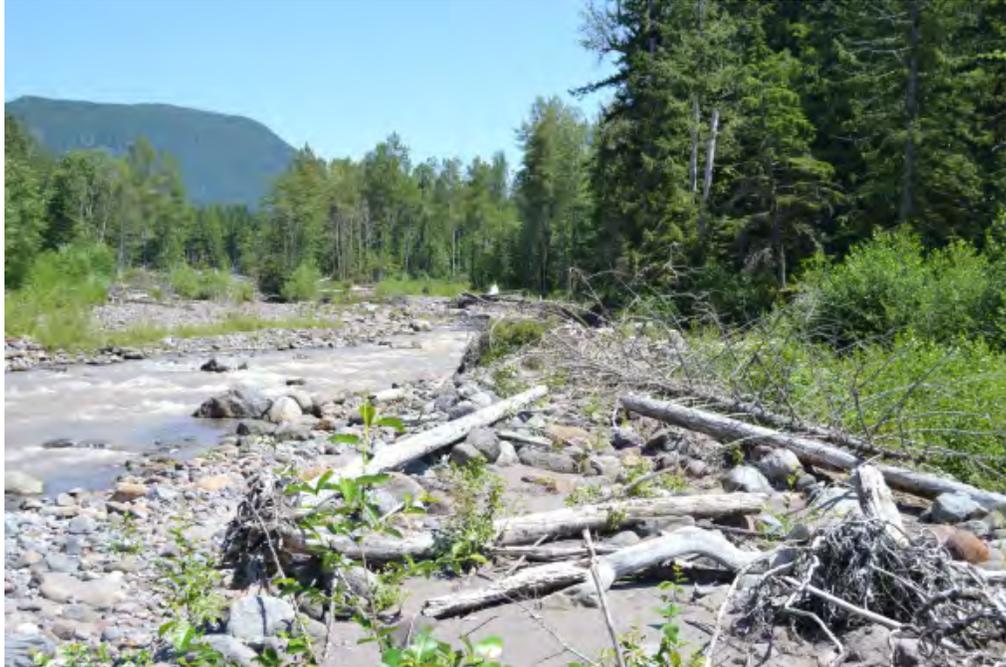
Sandy River, flood debris

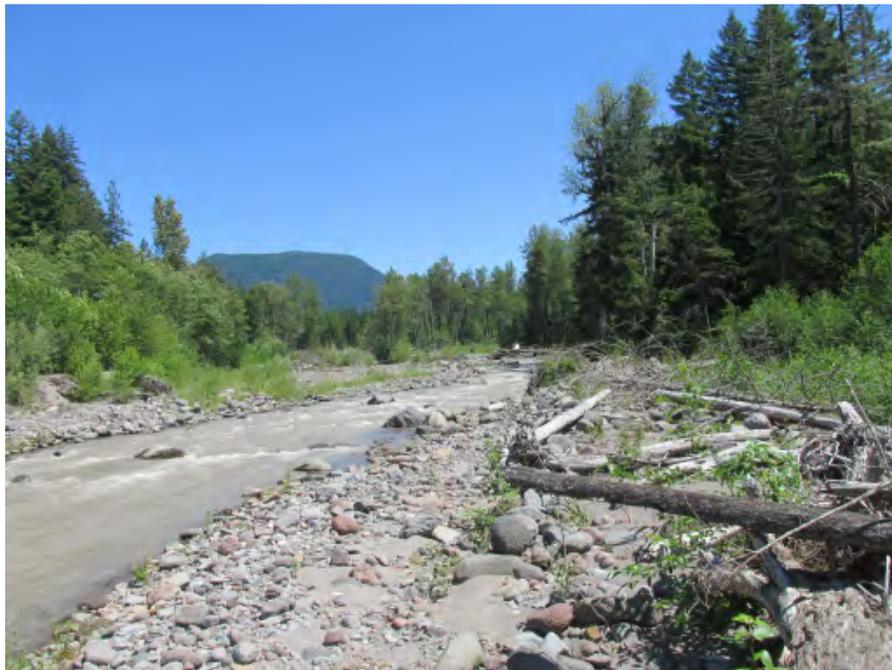
Potential new bridge location across Sandy River

The overall channel migration zone through the study area does not appear to have any confined or narrow areas ideal for a crossing. However, there are several locations where the channel has maintained a more consistent and confined route within the last 50 years. One location, in the vicinity of the east end of Autumn Lane, appears to provide the best opportunity for a crossing location with a narrow flood hazard zone combined with a more confined recent historic channel migration zone (approximately 250 foot width). Field reconnaissance confirmed that this location would be the most practical for a crossing within the study area. Alternatives associated with this location are called the Zigzag Mountain Alternatives.

Lidar mapping shows an old abandoned channel within the channel migration zone north of the potential bridge site. This was confirmed by field reconnaissance. Under current conditions the potential for the river to shift into this old channel during the next flood is high. The old channel could send flood waters across several residential properties and along the existing Lolo Pass Road. Constructing a new embankment across the old channel could act to prevent such a catastrophic avulsion from occurring. Further detailed analysis and evaluation will be

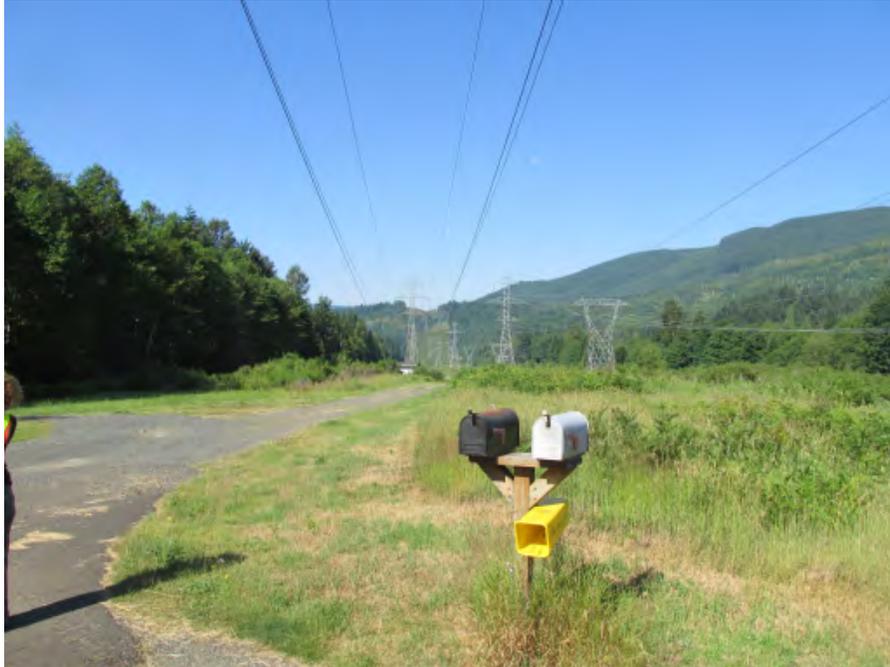
Powerline Corridor, looking southwest from Aschoff Road

Review of the power line access road revealed that its use as a primary access route would not be practical for a number of reasons. The road traverses over steep mountainous terrain which rises 800 feet above the valley floor. The road crosses multiple drainages and areas identified as geologic hazards. Improving this road from its current primitive condition to a primary access would require over six miles of road construction. Much of the roadway would have to be re-aligned to meet design safety standards. Construction impacts and costs would be significant. The new route would require an extensive amount of regular maintenance and snow removal during the winter months since it traverses hazardous and high elevation terrain.

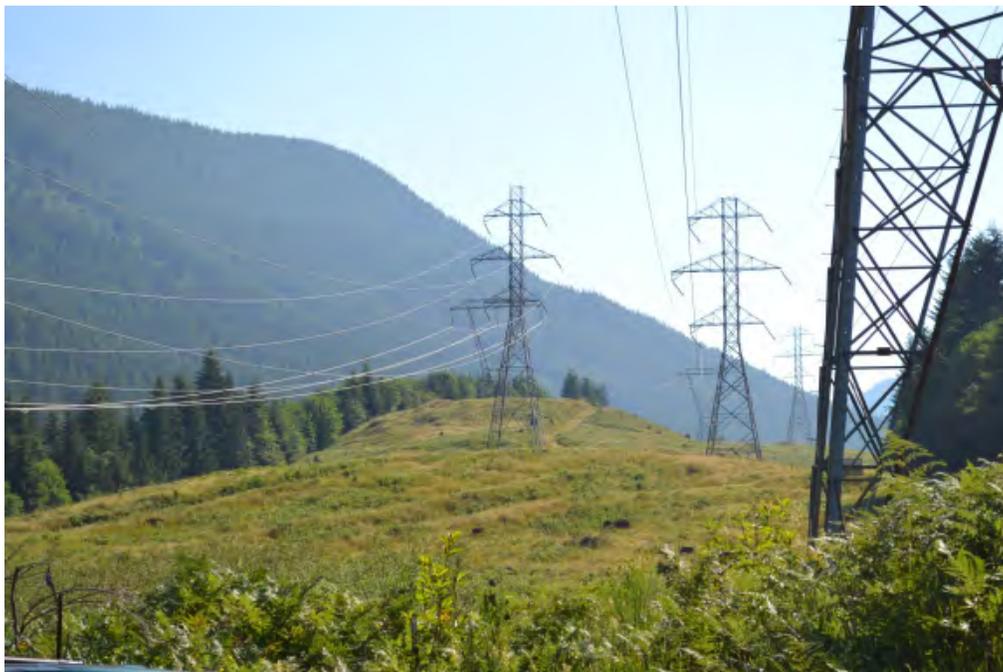
Powerline Corridor, looking northeast from Aschoff Road

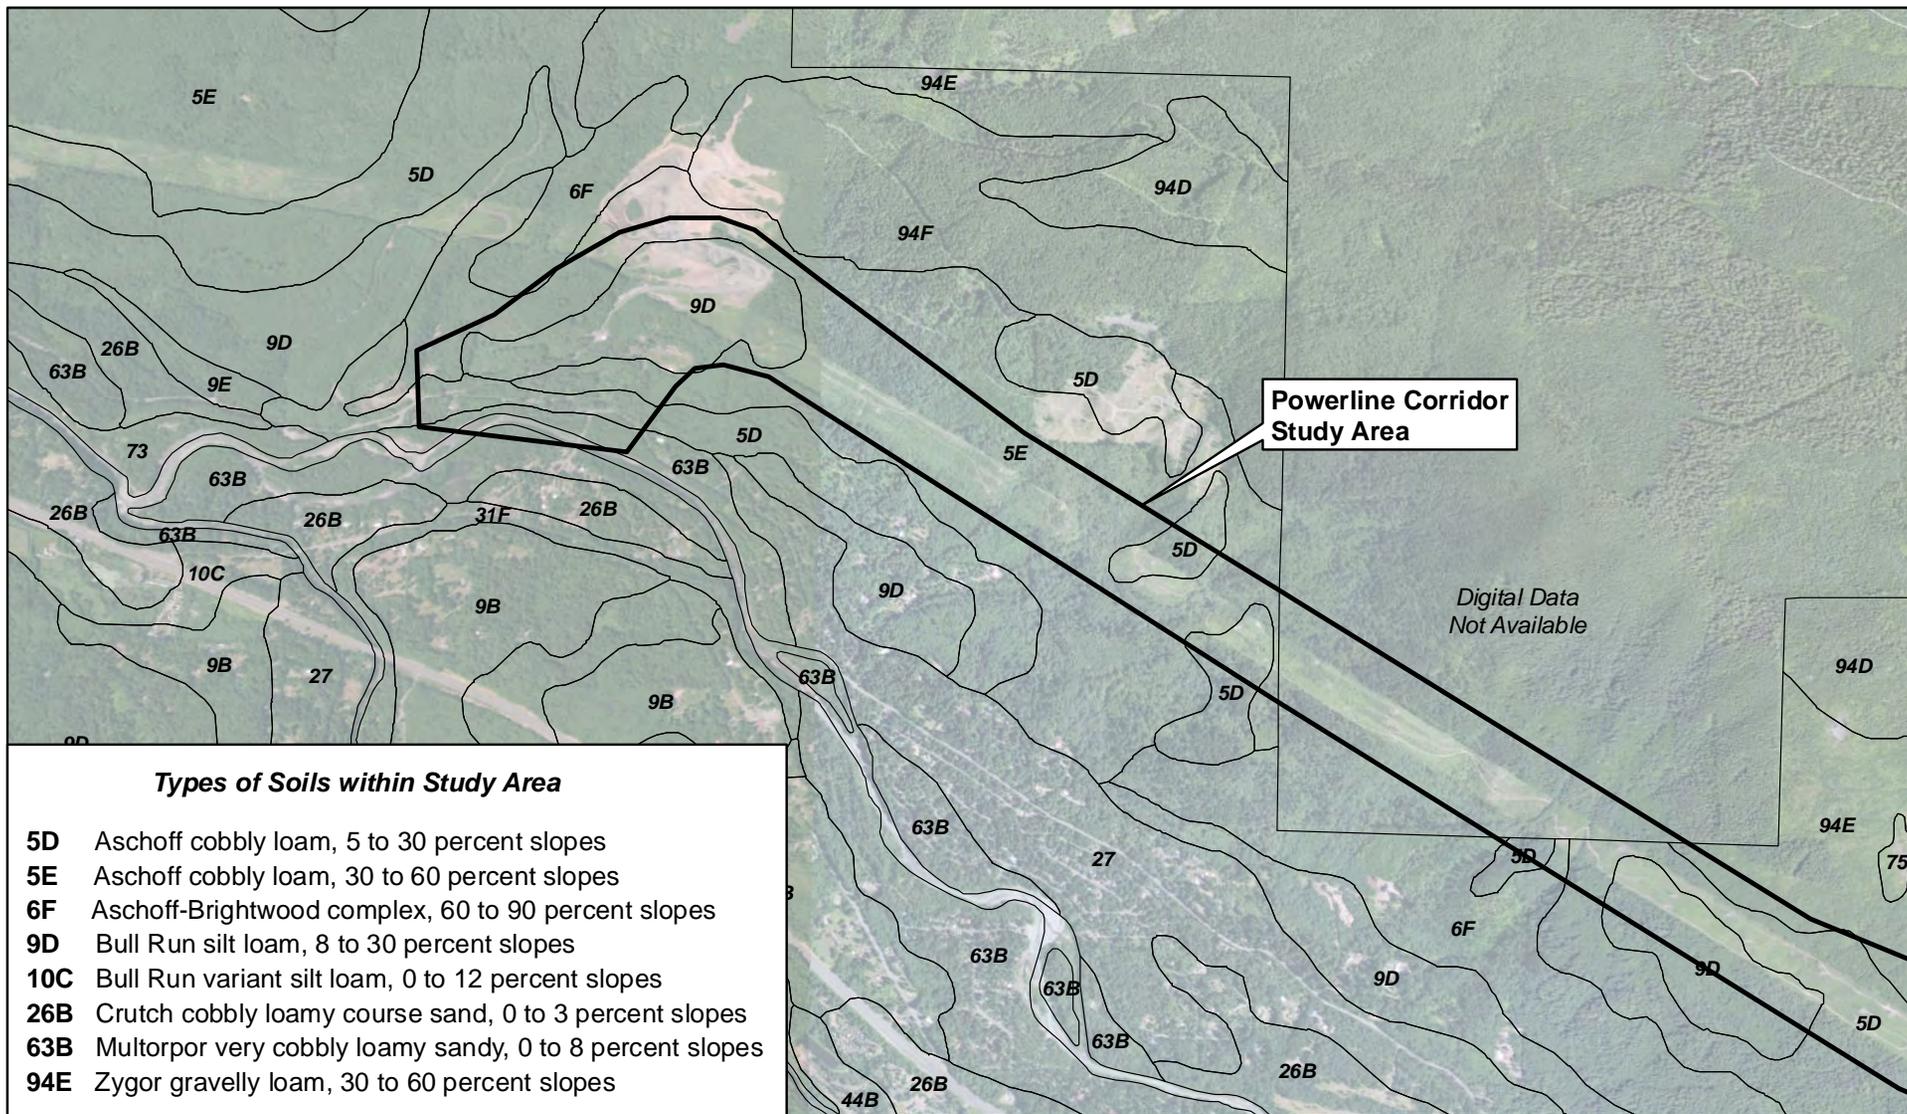
**Figure 3, Sheet 1**  
Soil Survey

The Clackamas Soil Survey shows seven general soil types within the study area (Figure 3). None of them are listed as hydric (formed under wet conditions) by the Natural Resource Conservation Service (NRCS 2014). Therefore, soils mapping does not indicate that unmapped areas may contain wetlands. However, given the high rainfall totals in the area, the position of the Powerline SA on a steep slope below the Bull Run Watershed, and the position of the Sandy River SA at the base of steep forested slopes, unmapped wetlands fed by groundwater are likely to occur.

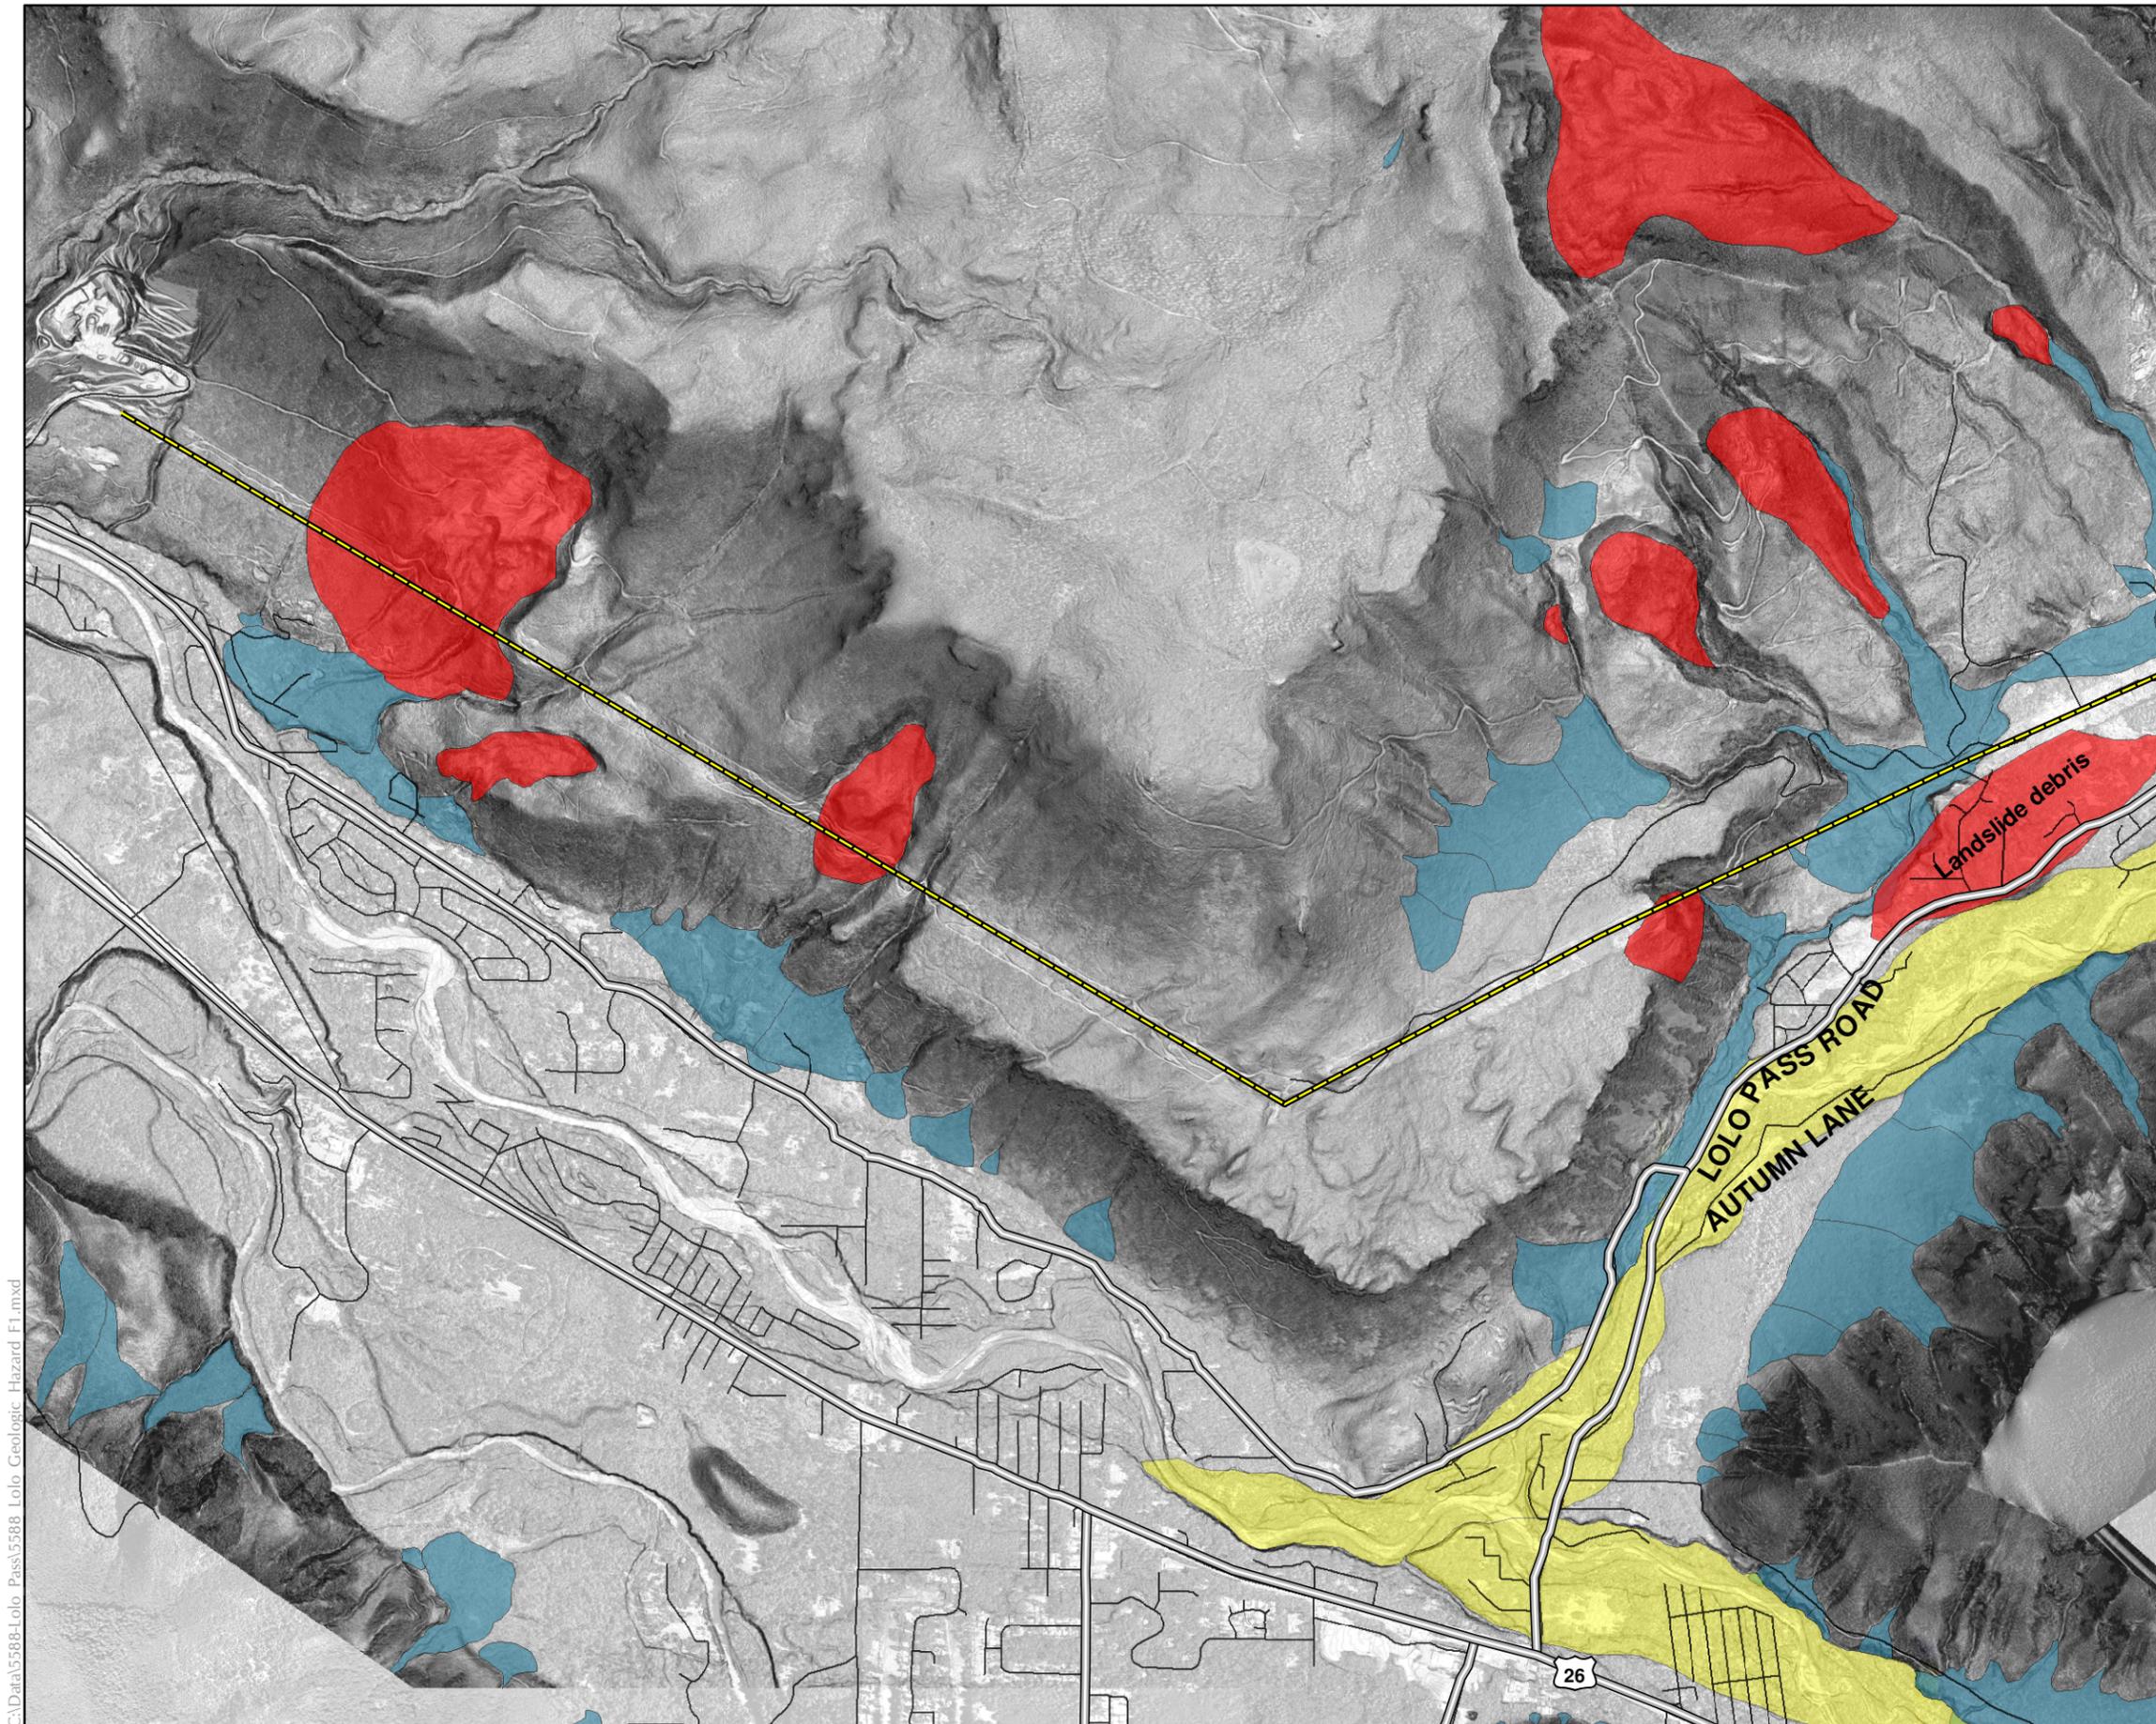
## GEOLOGIC HAZARD MAP

- Alluvial Fan
- Landslide
- Debris Flow
- Power Line Alignment

Note: gray-toned areas are rock units or other areas not mapped as a recognized geologic hazard.
