CLACKAMAS COUNTY WATER ENVIRONMENT SERVICES
CLACKAMAS COUNTY SERVICE DISTRICT #1
BENTHIC MACROINVERTEBRATE AND GEOMORPHOLOGICAL
MONITORING REPORT 2014

FINAL REPORT- June 3, 2015

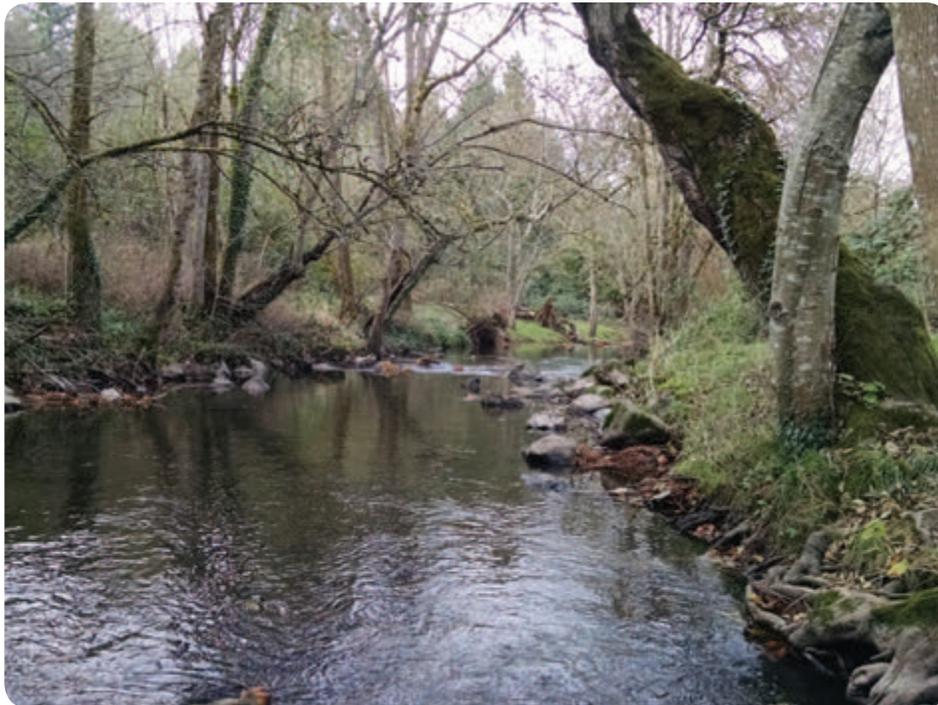
Average Bankfull Width, Depth and Width/Depth Ratio:

Year	Average W _{BF}	Average D _{BF}	Average W/D
2009	39.9	2.3	17.1
2011	41.2	2.54	18.9
2014	37.7	2.0	19.1

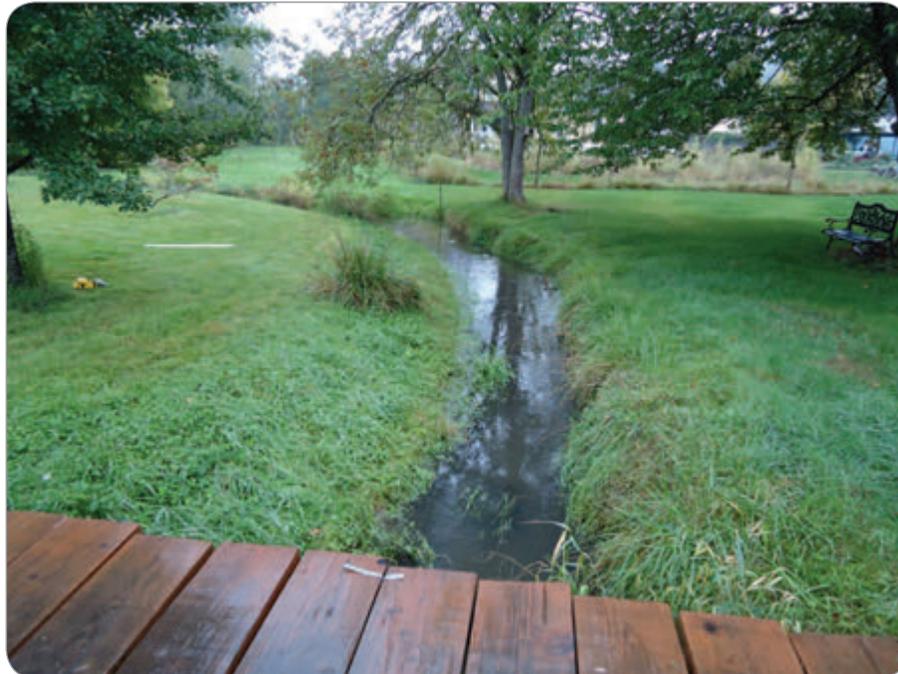
Average Bankfull Width, Depth and Width/Depth Ratio:

Year	Average W _{BF}	Average D _{BF}	Average W/D
2009	12.3	2.2	5.7
2011	10.6	2.0	5.4
2014	8.7	1.4	6.5

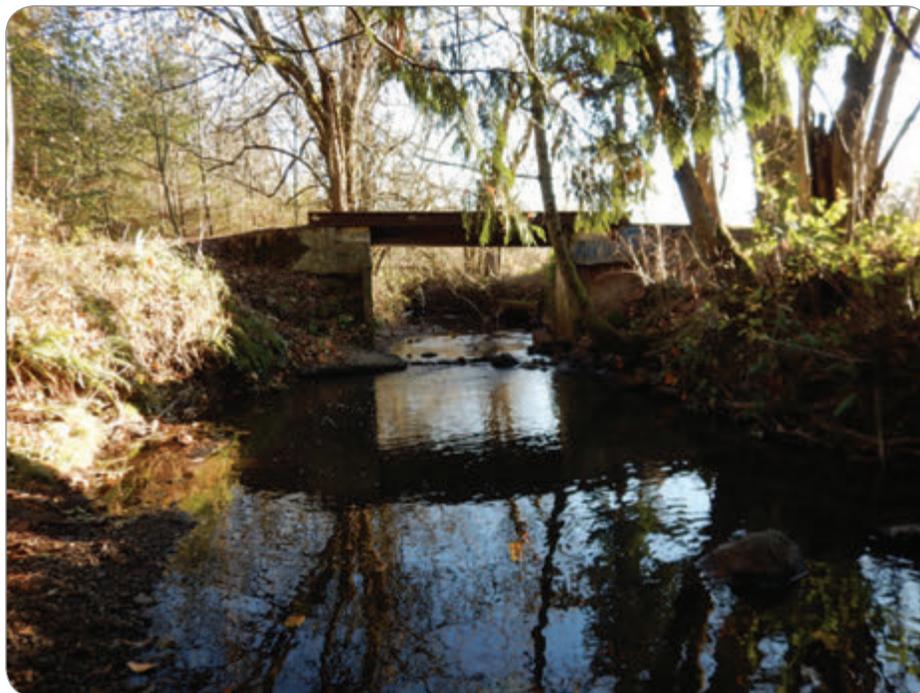
Average Bankfull Width, Depth and Width/Depth Ratio:

Year	Average W _{BF}	Average D _{BF}	Average W/D
2009	21.2	2.3	9.1
2011	24.2	3.6	6.8
2014	22.6	1.4	15.7

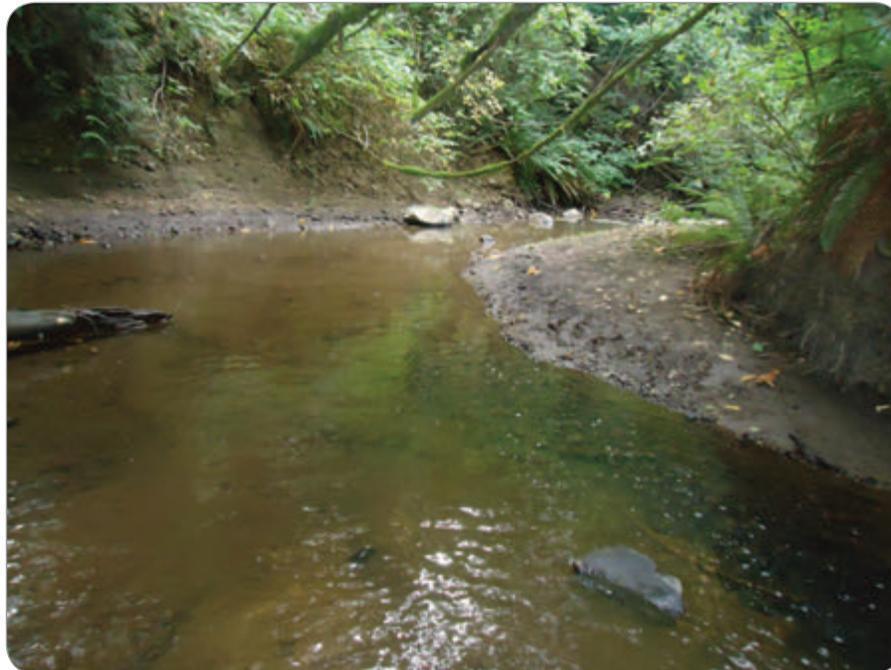
Average Bankfull Width, Depth and Width/Depth Ratio:

Year	Average W _{BF}	Average D _{BF}	Average W/D
2009	23.1	1.7	15.2
2011	26.3	2.4	11.3
2014	23.2	1.7	16.4

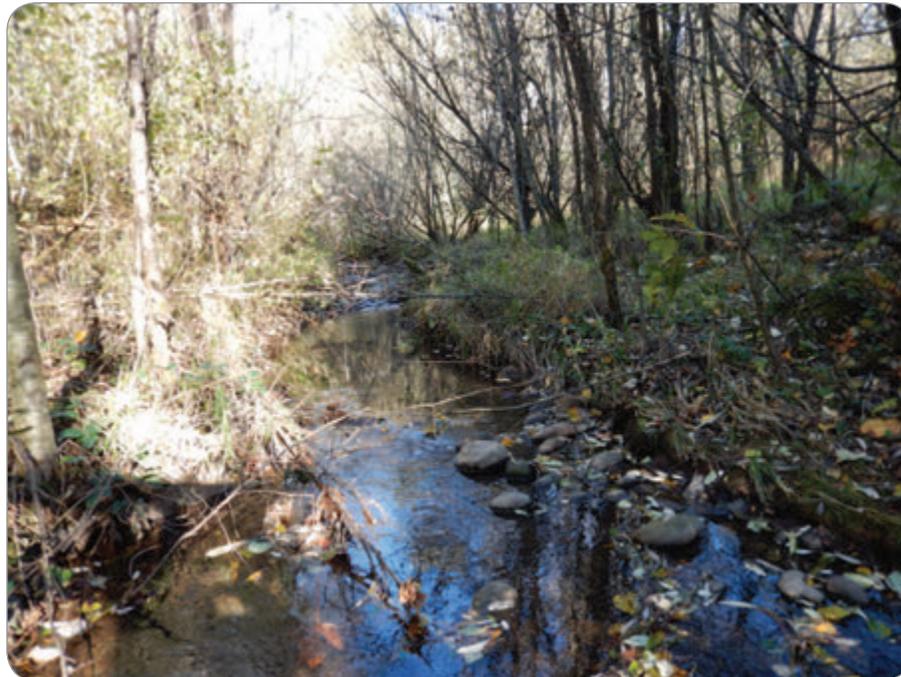
Average Bankfull Width, Depth and Width/Depth Ratio:

Year	Average W _{BF}	Average D _{BF}	Average W/D
2009	18.8	2.2	9.1
2011	14.1	1.6	8.7
2014	12.8	2.0	6.5

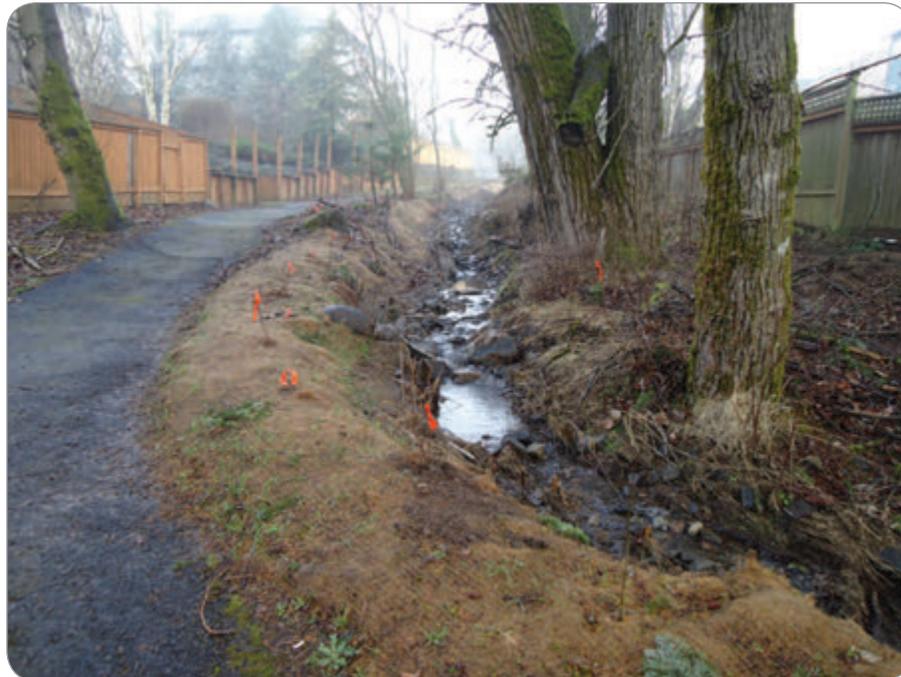
Average Bankfull Width, Depth and Width/Depth Ratio:

Year	Average W _{BF}	Average D _{BF}	Average W/D
2009	5.9	0.9	6.7
2011	4.4	1.0	4.3
2014	5.2	1.4	3.7

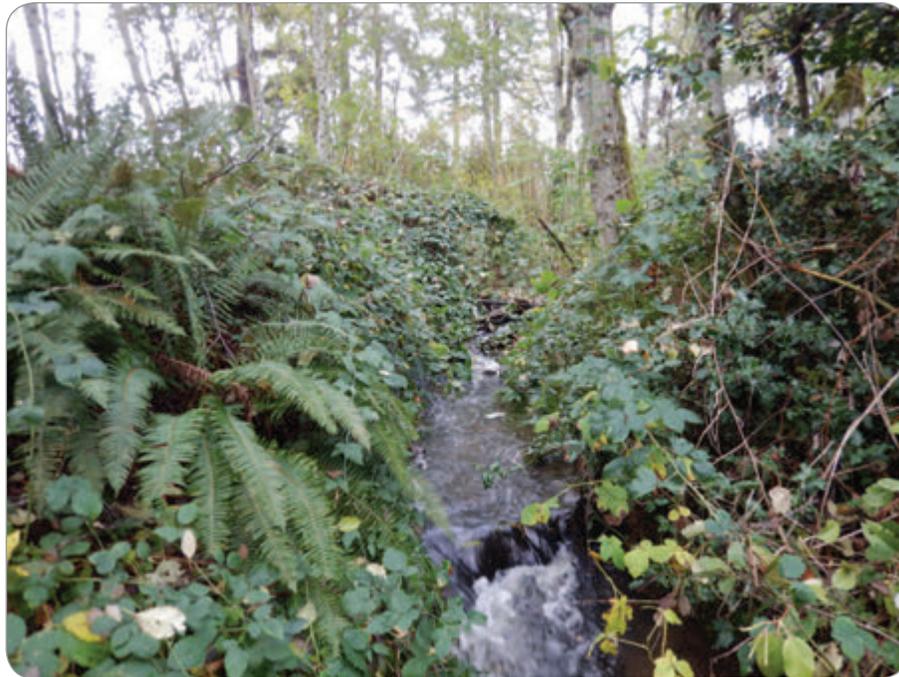
Average Bankfull Width, Depth and Width/Depth Ratio:

Year	Average W _{BF}	Average D _{BF}	Average W/D
2009	15.7	1.2	13.5
2011	16.1	1.3	12.9
2014	18.1	1.0	18.1

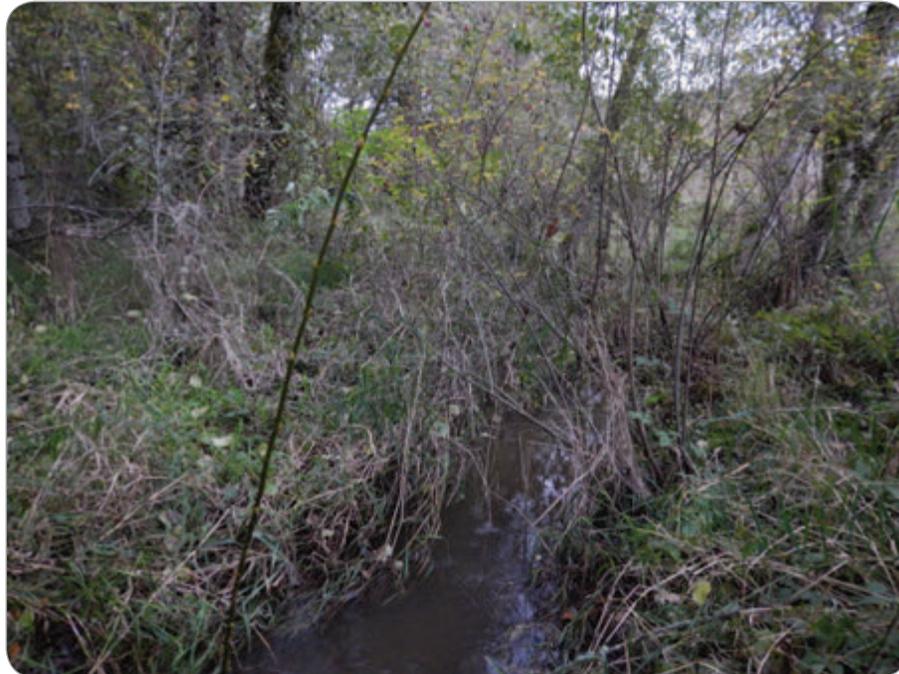
Average Bankfull Width, Depth and Width/Depth Ratio:

Year	Average W _{BF}	Average D _{BF}	Average W/D
2009	6.2	1.2	5.1
2011	8.5	1.4	6.1
2014	11.6	1.7	16.4

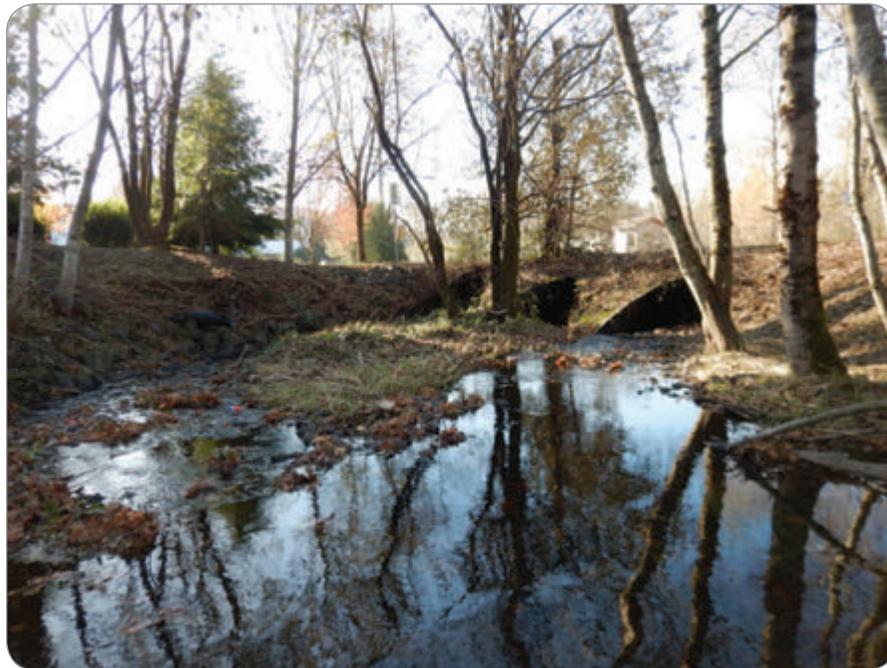
Average Bankfull Width, Depth and Width/Depth Ratio:

Year	Average W _{BF}	Average D _{BF}	Average W/D
2009	23.1	1.7	14.5
2011	24.4	1.7	16.4
2014	21.6	1.6	20.1

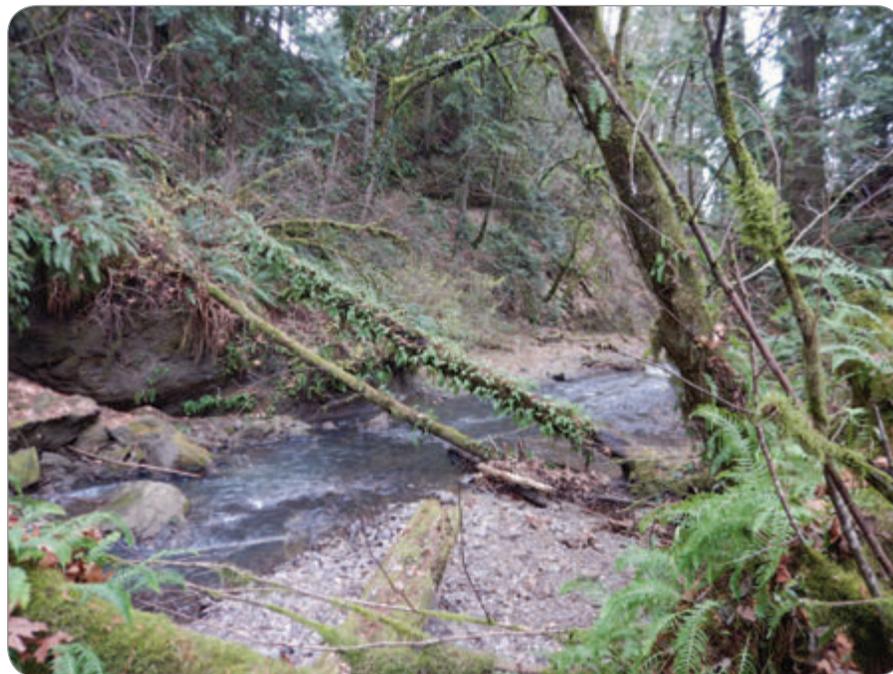
Average Bankfull Width, Depth and Width/Depth Ratio:

Year	Average W _{BF}	Average D _{BF}	Average W/D
2009	37.7	3.0	13.0
2011	36.6	2.6	18.9
2014	37.5	2.4	15.5

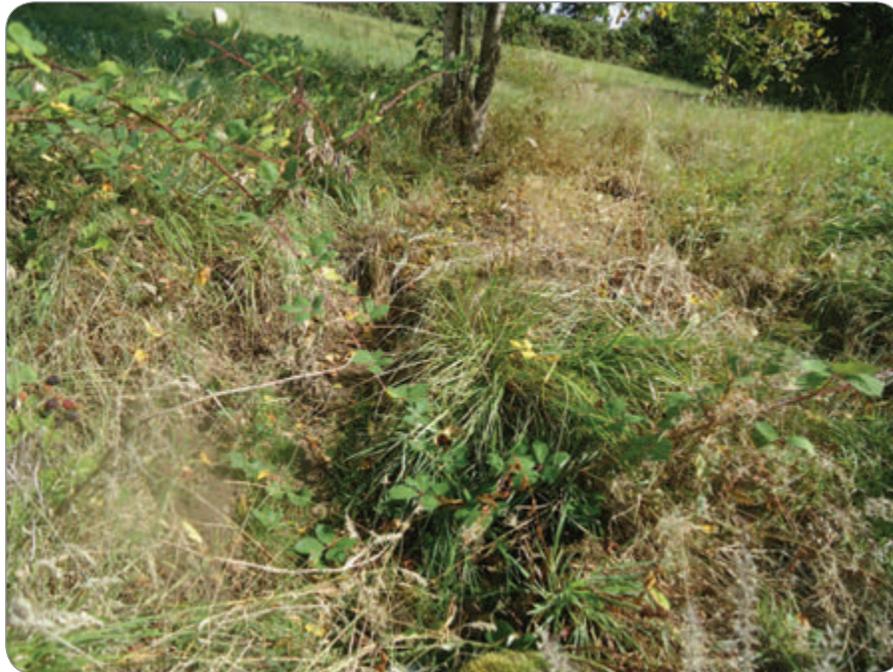
Average Bankfull Width, Depth and Width/Depth Ratio:

Year	Average W _{BF}	Average D _{BF}	Average W/D
2009	6.6	0.9	6.9
2011	7.7	1.1	7.5
2014	5.5	1.2	4.9

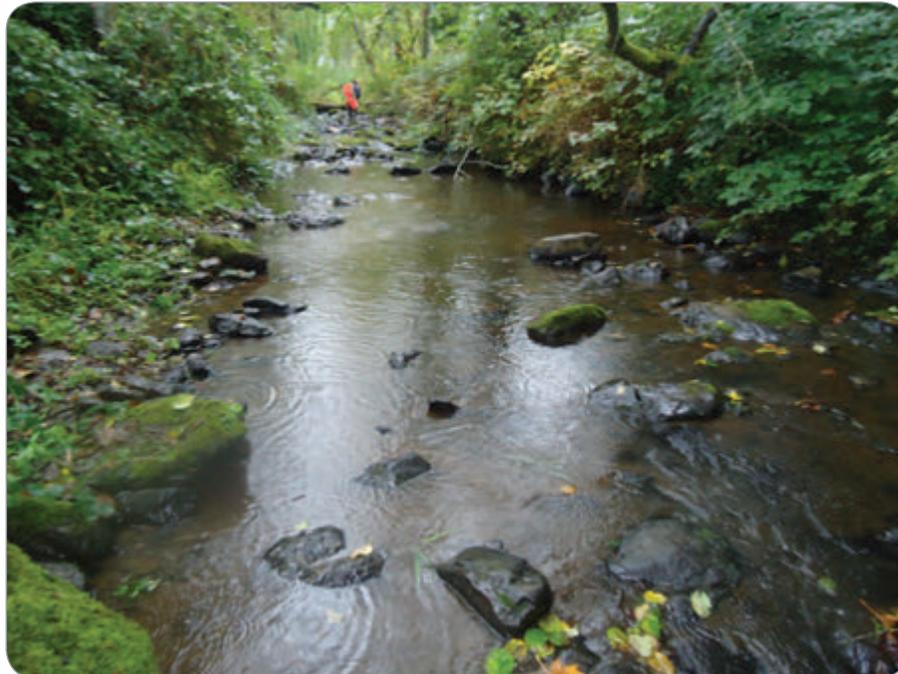
Average Bankfull Width, Depth and Width/Depth Ratio:

Year	Average W _{BF}	Average D _{BF}	Average W/D
2009	21.7	1.5	14.4
2011	23.1	1.4	17.8
2014	23.1	1.4	17.6

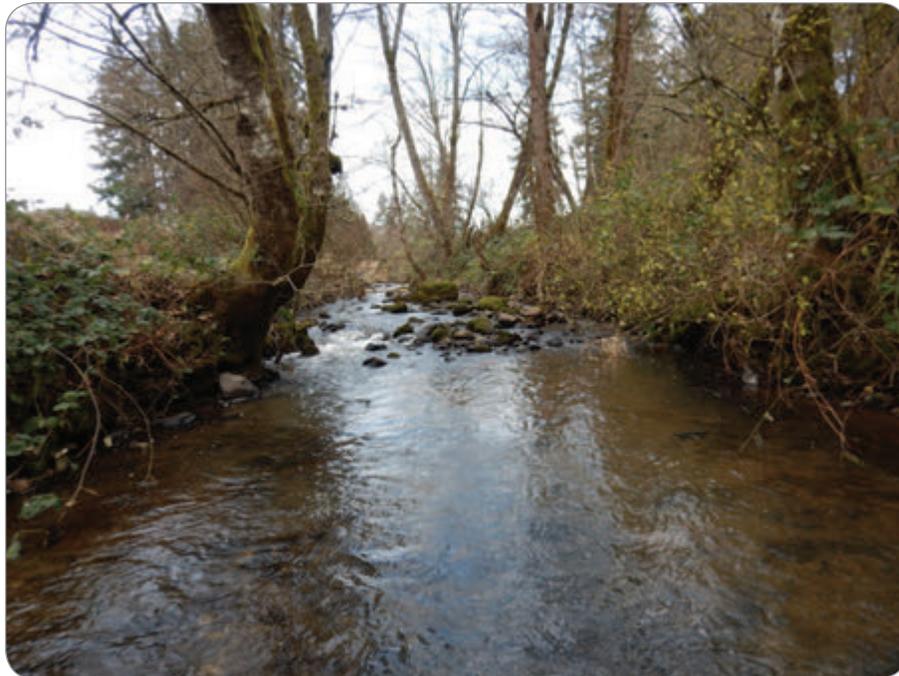
FIGURE A27

Average Bankfull Width, Depth and Width/Depth Ratio:

Year	Average W _{BF}	Average D _{BF}	Average W/D
2009	18.7	2.1	9.2
2011	19.7	2.2	11.3
2014	19.0	2.4	7.7

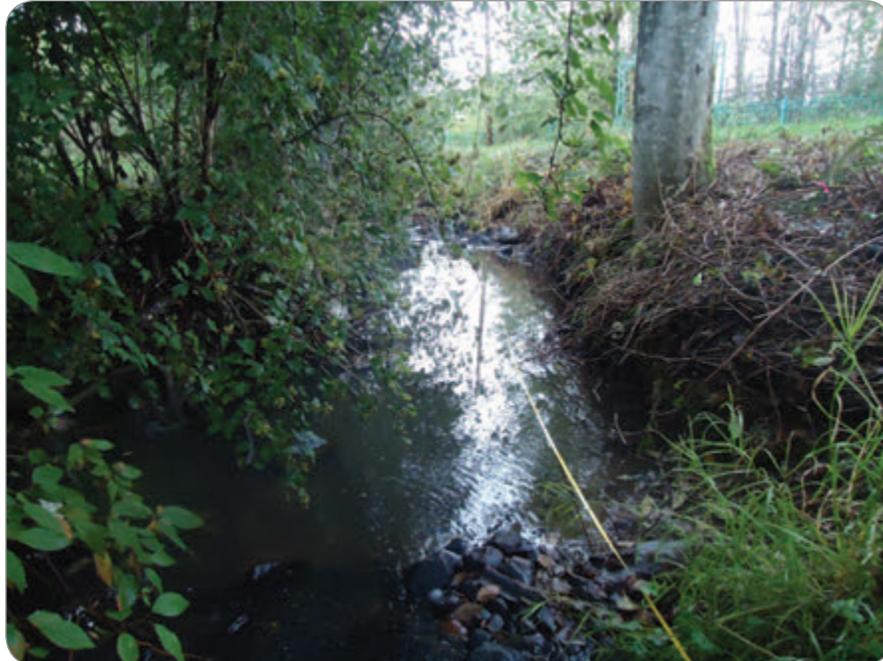
Average Bankfull Width, Depth and Width/Depth Ratio:

Year	Average W _{BF}	Average D _{BF}	Average W/D
2009	12.2	1.7	7.2
2011	13.2	1.9	7.3
2014	11.5	1.3	9.2

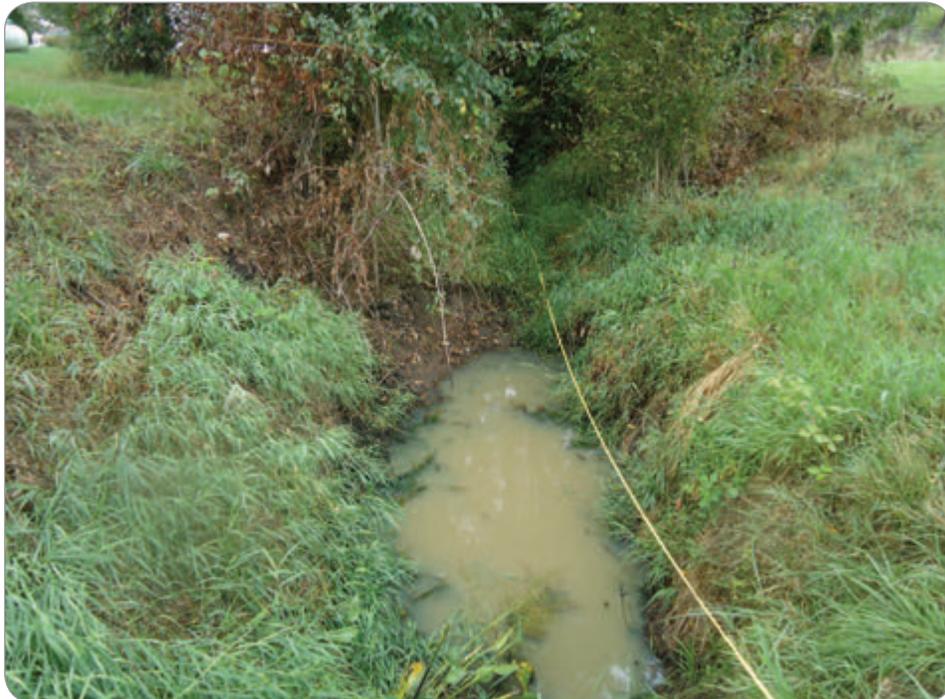
Average Bankfull Width, Depth and Width/Depth Ratio:

Year	Average W _{BF}	Average D _{BF}	Average W/D
2009	9.1	2.1	4.7
2011	11.0	2.3	5.5
2014	11.6	2.3	5.2

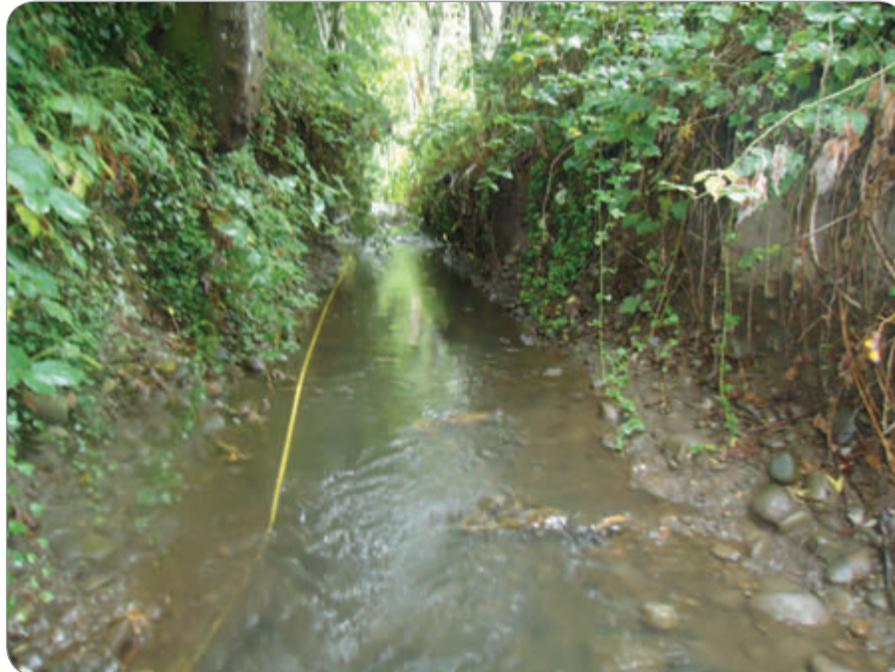
Average Bankfull Width, Depth and Width/Depth Ratio:

Year	Average W _{BF}	Average D _{BF}	Average W/D
2009	10.7	2.5	4.6
2011	11.6	3.5	3.4
2014	8.8	1.2	7.8

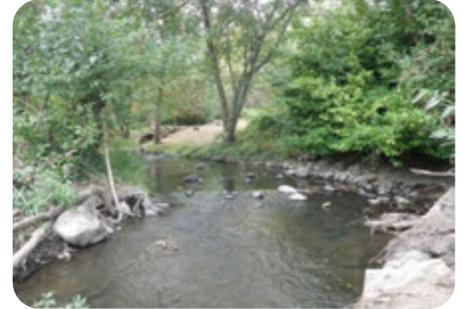
Survey start, facing upstream

% Fines (FN)	2.7
% Sand (SA)	3.6
% Gravel, Fine (GF)	13.6
% Gravel, Coarse (GC)	19.1
% Cobble (CB)	35.5
% Boulder (BL)	23.6
% Bedrock (BR)	1.8
% Wood (WD)	0.0
% Hardpan (HP)	0.0
% Other (OT)	0.0
% Embeddedness	21.6
Large Wood Tally (pieces/m)	0.12
Eroding Banks (%)	12
Undercut Banks (%)	3

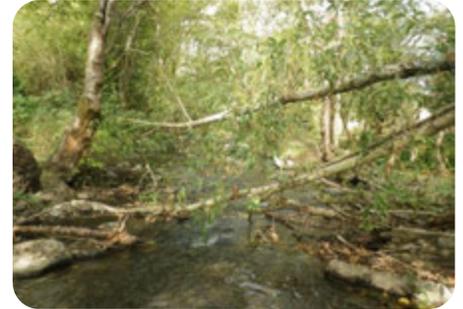
Survey end, facing downstream

Canopy Cover (%)	77
Riparian Buffer Width (m)	5
Riparian Zone Tree Cover (%)	45
Riparian Zone Non-Native Cover (%)	20
Dom Adjacent Land Use	RES

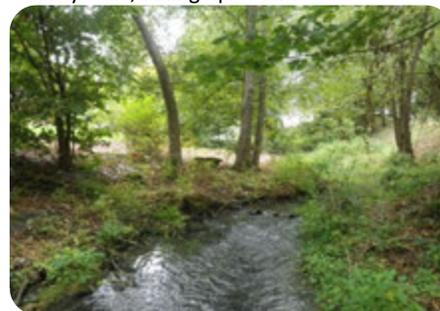
Survey start, facing upstream

% Fines (FN)	0.0
% Sand (SA)	6.7
% Gravel, Fine (GF)	8.6
% Gravel, Coarse (GC)	41.9
% Cobble (CB)	39.0
% Boulder (BL)	3.8
% Bedrock (BR)	0.0
% Wood (WD)	0.0
% Hardpan (HP)	0.0
% Other (OT)	0.0
% Embeddedness	17.4
Large Wood Tally (pieces/m)	0.00
Eroding Banks (%)	5
Undercut Banks (%)	32

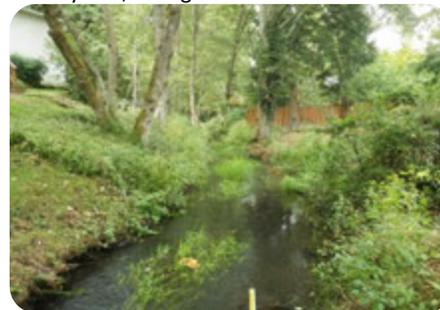
Survey end, facing downstream

Canopy Cover (%)	89
Riparian Buffer Width (m)	4
Riparian Zone Tree Cover (%)	75
Riparian Zone Non-Native Cover (%)	30
Dom Adjacent Land Use	RES

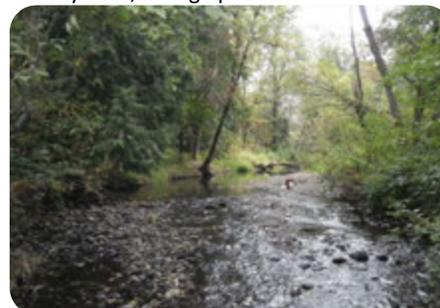
Survey start, facing upstream

% Fines (FN)	0.0
% Sand (SA)	0.0
% Gravel, Fine (GF)	2.8
% Gravel, Coarse (GC)	35.2
% Cobble (CB)	61.1
% Boulder (BL)	0.9
% Bedrock (BR)	0.0
% Wood (WD)	0.0
% Hardpan (HP)	0.0
% Other (OT)	0.0
% Embeddedness	6.2
Large Wood Tally (pieces/m)	0.12
Eroding Banks (%)	25
Undercut Banks (%)	9

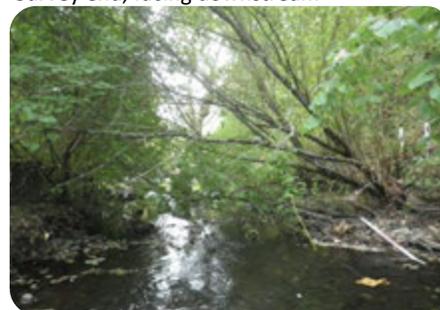
Survey end, facing downstream

Canopy Cover (%)	83
Riparian Buffer Width (m)	55
Riparian Zone Tree Cover (%)	65
Riparian Zone Non-Native Cover (%)	15
Dom Adjacent Land Use	RES

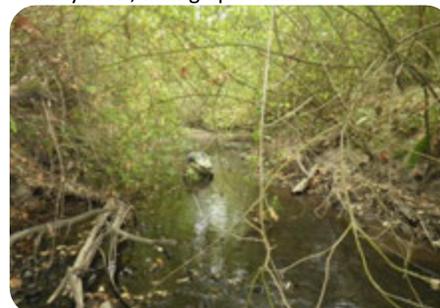
Survey start, facing upstream

% Fines (FN)	0.0
% Sand (SA)	3.6
% Gravel, Fine (GF)	24.3
% Gravel, Coarse (GC)	64.9
% Cobble (CB)	7.2
% Boulder (BL)	0.0
% Bedrock (BR)	0.0
% Wood (WD)	0.0
% Hardpan (HP)	0.0
% Other (OT)	0.0
% Embeddedness	19.0
Large Wood Tally (pieces/m)	0.09
Eroding Banks (%)	69
Undercut Banks (%)	12

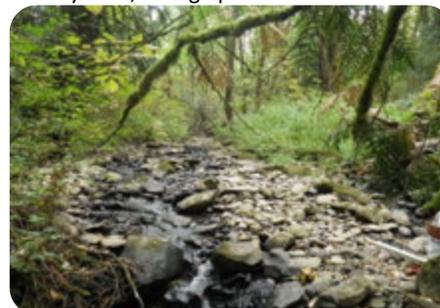
Survey start, facing upstream

% Fines (FN)	0.0
% Sand (SA)	0.0
% Gravel, Fine (GF)	8.1
% Gravel, Coarse (GC)	28.8
% Cobble (CB)	56.8
% Boulder (BL)	6.3
% Bedrock (BR)	0.0
% Wood (WD)	0.0
% Hardpan (HP)	0.0
% Other (OT)	0.0
% Embeddedness	18.6
Large Wood Tally (pieces/m)	0.05
Eroding Banks (%)	2.08
Undercut Banks (%)	2.24

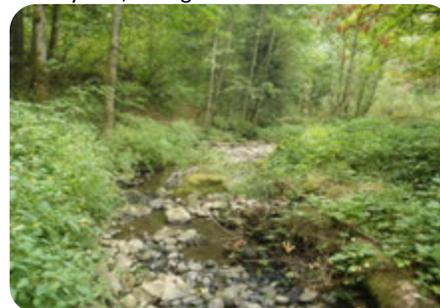
Survey end, facing downstream

Canopy Cover (%)	93.24
Riparian Buffer Width (m)	50
Riparian Zone Tree Cover (%)	80
Riparian Zone Non-Native Cover (%)	10
Dom Adjacent Land Use	RES

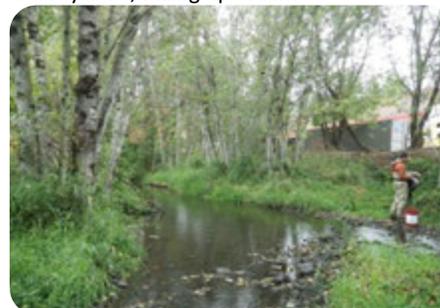
Survey start, facing upstream

% Fines (FN)	0.0
% Sand (SA)	0.9
% Gravel, Fine (GF)	11.5
% Gravel, Coarse (GC)	51.3
% Cobble (CB)	34.5
% Boulder (BL)	1.8
% Bedrock (BR)	0.0
% Wood (WD)	0.0
% Hardpan (HP)	0.0
% Other (OT)	0.0
% Embeddedness	11.2
Large Wood Tally (pieces/m)	0.08
Eroding Banks (%)	6
Undercut Banks (%)	14

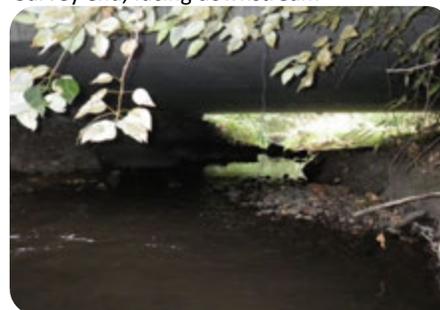
Survey end, facing downstream

Canopy Cover (%)	85
Riparian Buffer Width (m)	9
Riparian Zone Tree Cover (%)	53
Riparian Zone Non-Native Cover (%)	43
Dom Adjacent Land Use	COM

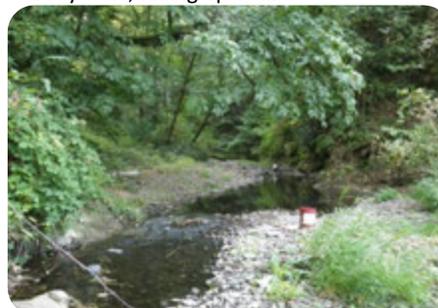
Survey start, facing upstream

% Fines (FN)	0.0
% Sand (SA)	2.5
% Gravel, Fine (GF)	34.5
% Gravel, Coarse (GC)	55.5
% Cobble (CB)	5.9
% Boulder (BL)	1.7
% Bedrock (BR)	0.0
% Wood (WD)	0.0
% Hardpan (HP)	0.0
% Other (OT)	0.0
% Embeddedness	11.6
Large Wood Tally (pieces/m)	0.04
Eroding Banks (%)	57
Undercut Banks (%)	1

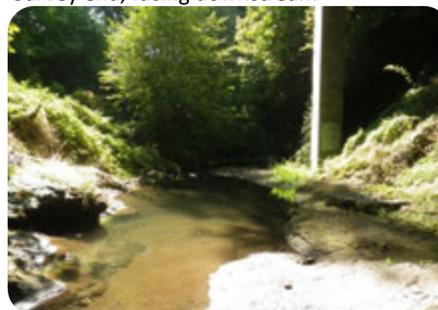
Survey end, facing downstream

Canopy Cover (%)	90
Riparian Buffer Width (m)	75
Riparian Zone Tree Cover (%)	70
Riparian Zone Non-Native Cover (%)	5
Dom Adjacent Land Use	COM/RES

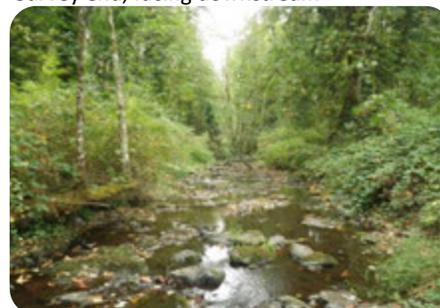
Survey end, facing downstream

Canopy Cover (%)	93
Riparian Buffer Width (m)	75
Riparian Zone Tree Cover (%)	73
Riparian Zone Non-Native Cover (%)	45
Dom Adjacent Land Use	RES

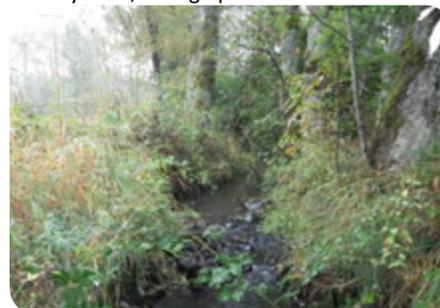
Survey start, facing upstream

% Fines (FN)	0.0
% Sand (SA)	2.8
% Gravel, Fine (GF)	11.2
% Gravel, Coarse (GC)	34.6
% Cobble (CB)	47.7
% Boulder (BL)	3.7
% Bedrock (BR)	0.0
% Wood (WD)	0.0
% Hardpan (HP)	0.0
% Other (OT)	0.0
% Embeddedness	10.7
Large Wood Tally (pieces/m)	0.04
Eroding Banks (%)	15
Undercut Banks (%)	11

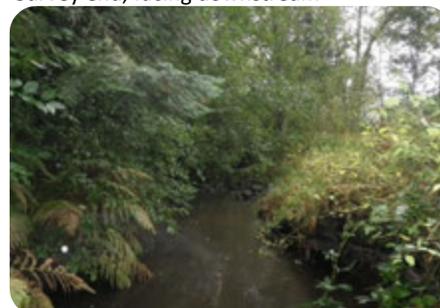
Survey end, facing downstream

Canopy Cover (%)	93.01
Riparian Buffer Width (m)	6
Riparian Zone Tree Cover (%)	45
Riparian Zone Non-Native Cover (%)	10
Dom Adjacent Land Use	RES

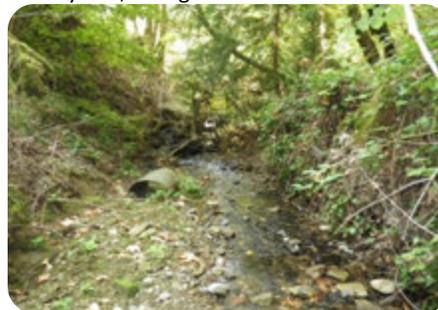
Survey end, facing downstream

Canopy Cover (%)	90
Riparian Buffer Width (m)	48
Riparian Zone Tree Cover (%)	65
Riparian Zone Non-Native Cover (%)	28
Dom Adjacent Land Use	COM/RES

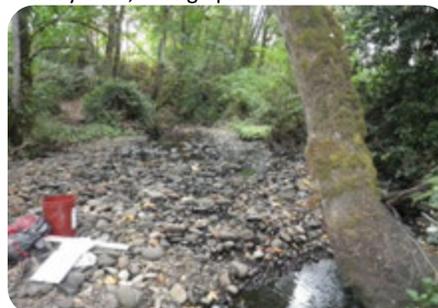
Survey start, facing upstream

% Fines (FN)	0.0
% Sand (SA)	0.0
% Gravel, Fine (GF)	4.8
% Gravel, Coarse (GC)	53.8
% Cobble (CB)	41.3
% Boulder (BL)	0.0
% Bedrock (BR)	0.0
% Wood (WD)	0.0
% Hardpan (HP)	0.0
% Other (OT)	0.0
% Embeddedness	1.2
Large Wood Tally (pieces/m)	0.01
Eroding Banks (%)	3
Undercut Banks (%)	8

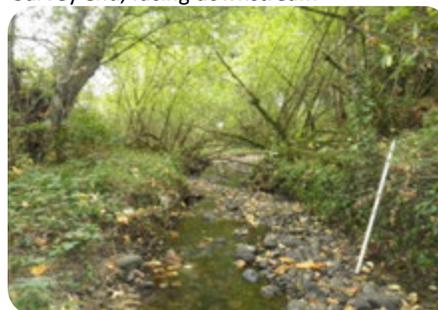
Survey end, facing downstream

Canopy Cover (%)	94.85
Riparian Buffer Width (m)	11
Riparian Zone Tree Cover (%)	80
Riparian Zone Non-Native Cover (%)	30
Dom Adjacent Land Use	IND

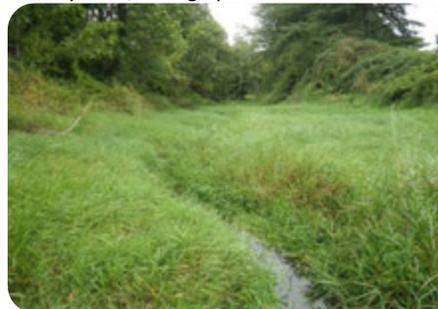
Survey start, facing upstream

% Fines (FN)	72.6
% Sand (SA)	15.9
% Gravel, Fine (GF)	0.0
% Gravel, Coarse (GC)	0.0
% Cobble (CB)	0.0
% Boulder (BL)	0.0
% Bedrock (BR)	0.0
% Wood (WD)	11.5
% Hardpan (HP)	0.0
% Other (OT)	0.0
% Embeddedness	92.7
Large Wood Tally (pieces/m)	0.12
Eroding Banks (%)	0
Undercut Banks (%)	0

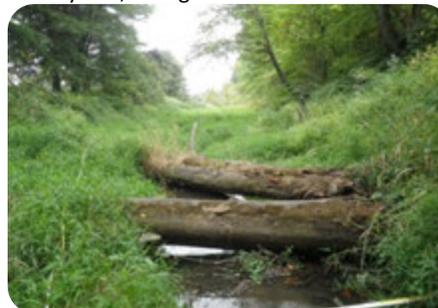
Survey end, facing downstream

Canopy Cover (%)	58
Riparian Buffer Width (m)	18
Riparian Zone Tree Cover (%)	0
Riparian Zone Non-Native Cover (%)	100
Dom Adjacent Land Use	AG/RES

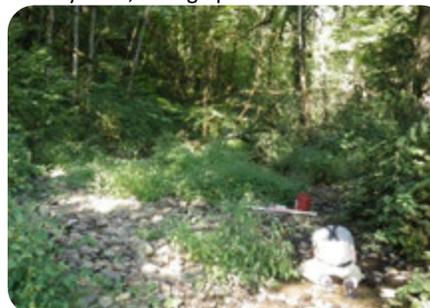
Survey start, facing upstream

% Fines (FN)	0.0
% Sand (SA)	0.9
% Gravel, Fine (GF)	3.4
% Gravel, Coarse (GC)	29.3
% Cobble (CB)	64.7
% Boulder (BL)	1.7
% Bedrock (BR)	0.0
% Wood (WD)	0.0
% Hardpan (HP)	0.0
% Other (OT)	0.0
% Embeddedness	10.4
Large Wood Tally (pieces/m)	0.09
Eroding Banks (%)	48
Undercut Banks (%)	1

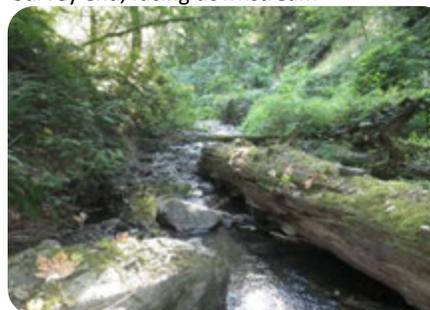
Survey end, facing downstream

Canopy Cover (%)	86
Riparian Buffer Width (m)	100
Riparian Zone Tree Cover (%)	70
Riparian Zone Non-Native Cover (%)	30
Dom Adjacent Land Use	RES/FOR
